Coexistence of Automatic Weather Station (AWS) System in harsh environmental conditions at National Meteorological Centre (NMC) Colombo, Sri Lanka.

Nuwan Kumarasinghe

Department of Meteorology, Bauddhaloka Mawatha, Colombo 07, Sri Lanka.

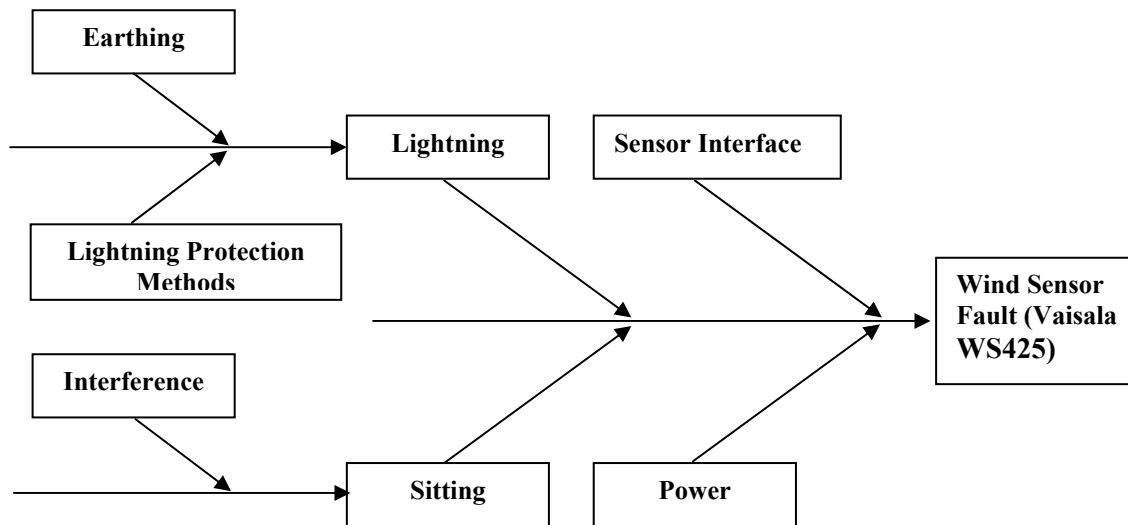
The main objective of this paper is to find the possible root cause of these faults. This paper further describes how a *Fishbone Diagram* (Fig. 1) can be used to identify problems with *Vaisala WS425* ultrasound wind sensor. It is a valid fact that the design of the ultrasound wind sensor is of the high quality and many automatic weather systems use this type of sensor for reliable data acquisition. There are so many possible factors (in no particular order) which may influence the faulty of the sensor;

Fig. 1 Fishbone Diagram for Fault Analysis

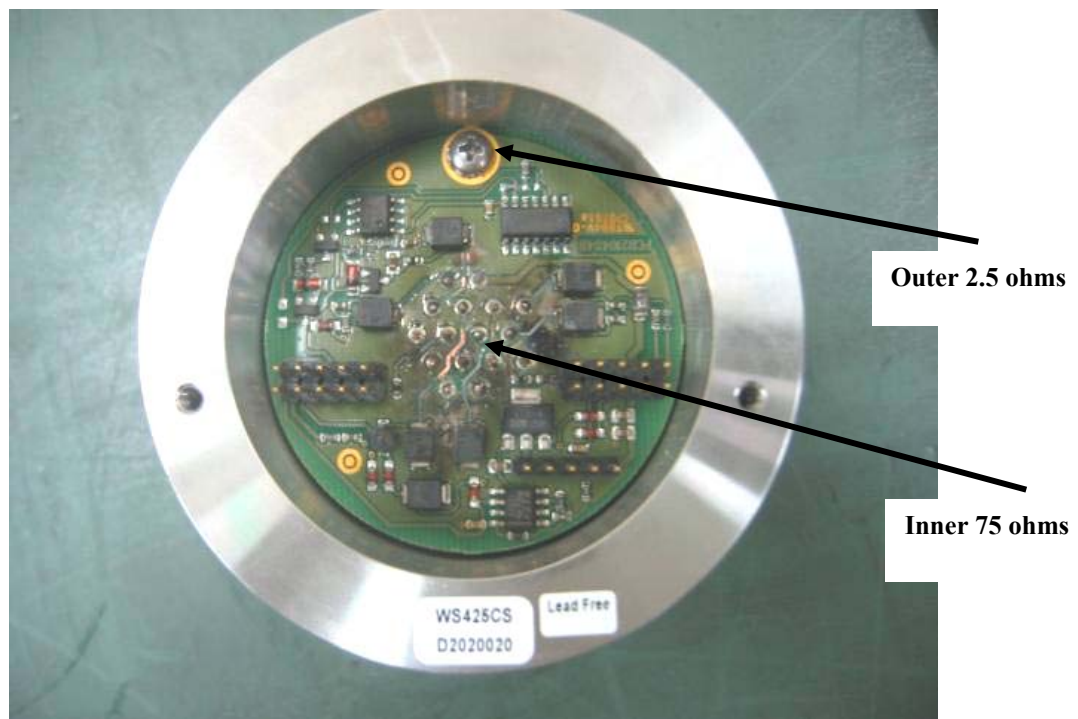
A photo of a damaged PCB circuit of a wind sensor (Ratnapura AWS site) is shown in Fig. 5.

Fig. 5 damaged wind sensor circuit in *Ratnapura* AWS Site

Earth resistance of the outer of the sensor is measured as 2.5 ohm where as the inner earth resistance value is measured as 75 ohms. Low resistance value of 2.5 ohm is given due to the consequence of lightning strike, otherwise this point should be in floating mode with a higher resistance value. Outer cover is normally not bonded to the lightning rod earth. This faulty is mainly due to the improper installation practice avoiding the equi-potential bonding. Photos of the damaged wind sensor adapter and circuit are given in Fig. 6 to Fig. 8.

As a remedial action, the following corrective measures have to be taken in AWS installations, otherwise by using only a high quality sensor like *Vaisala* WS 425, one cannot expect accurate and continuous data in AWS network.

- Equipotential bonding of all individual earth terminals in order to avoid possible flash over during lightning.
- Introduce lightning surge protection devices for power and data lines to avoid induced surges.

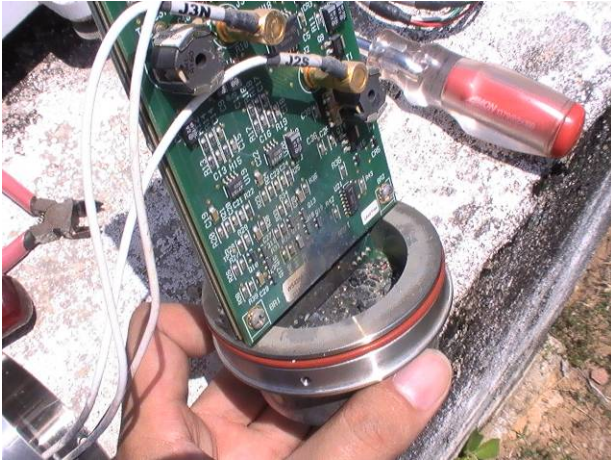
Fig. 6 Wind Sensor

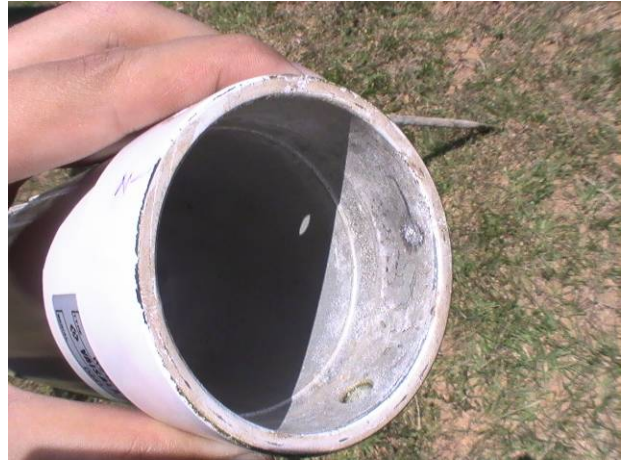
Fig. 7 Adapter Wind Sensor side

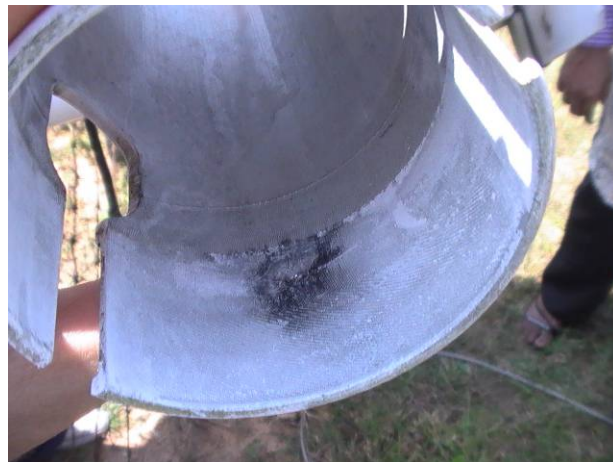
Fig. 8 Adapter AWS Mast side

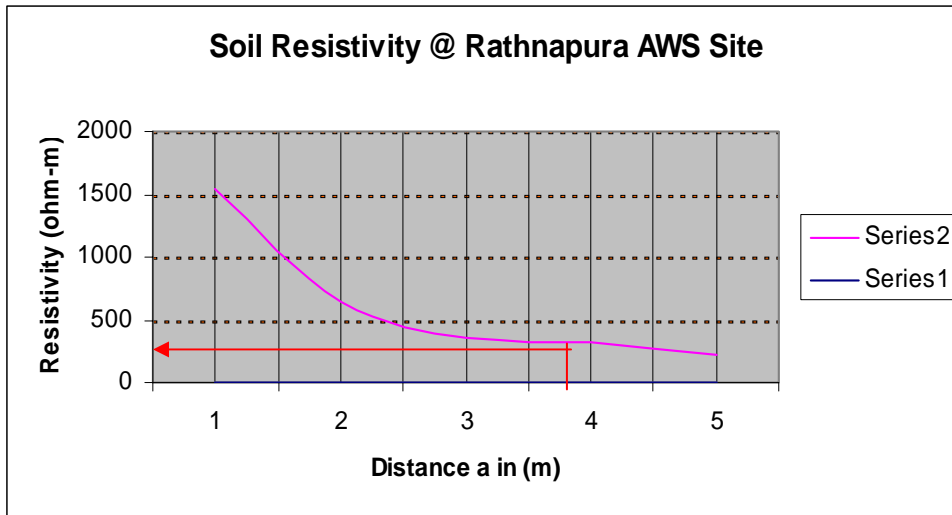
Measured soil resistivity, earth resistance of AWS mast, VSAT and the Data Logger in *Ratnapura* AWS site are 300, 17, 82 and 14 (Fig.9- 12) respectively. Three earth resistance values are high and different, therefore different earth potentials can be induced when lightning strikes. Hence lightning surge current passes through the mast to the earth by damaging the sensitive electronic circuitry. Soil resistivity value is also relatively high (300 Ω -m). Higher the resistivity of the ground, increases the shape of the potential gradient area.

Fig. 9 Soil Resistivity at Ratnapura AWS Site

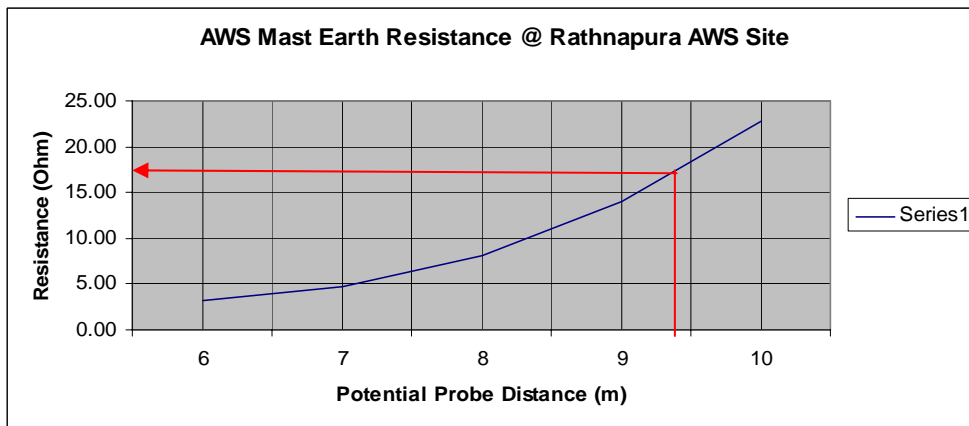
Fig. 10 Earth Resistance of AWS Mast at Ratnapura AWS site

- Measure earth resistance values of the AWS system in every 6 month period prior to intense lightning activity periods (two inter Monsoon periods March-April and October-November) and maintain the resultant earth resistance values below 10 ohms.

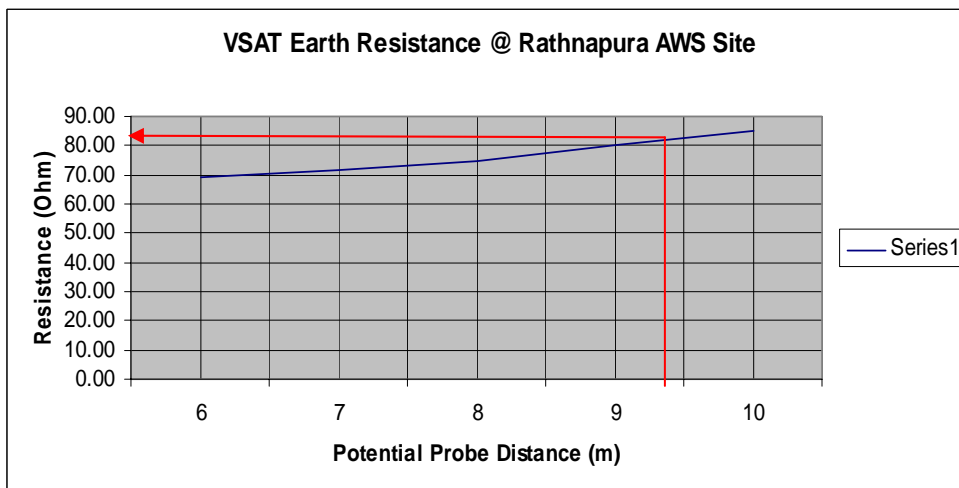
Fig. 11 Earth Resistance of VSAT at Ratnapura AWS site

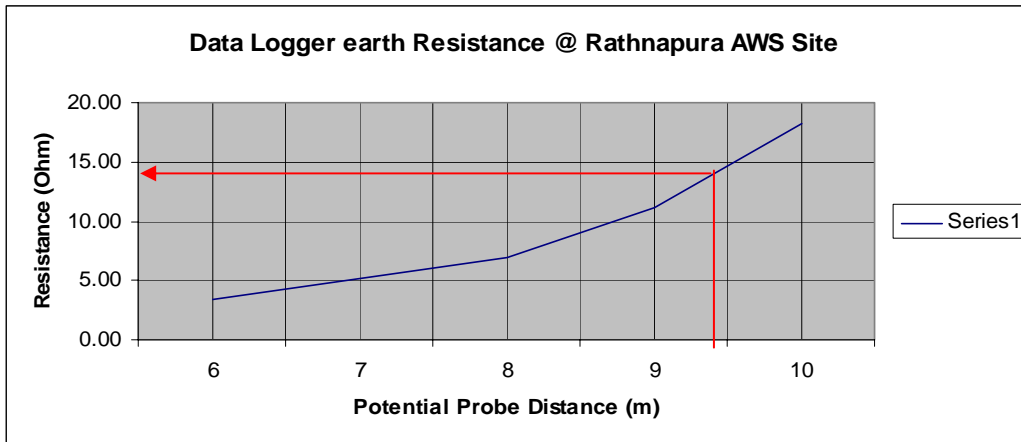
Fig. 12 Earth Resistance of Data Logger at Ratnapura AWS site

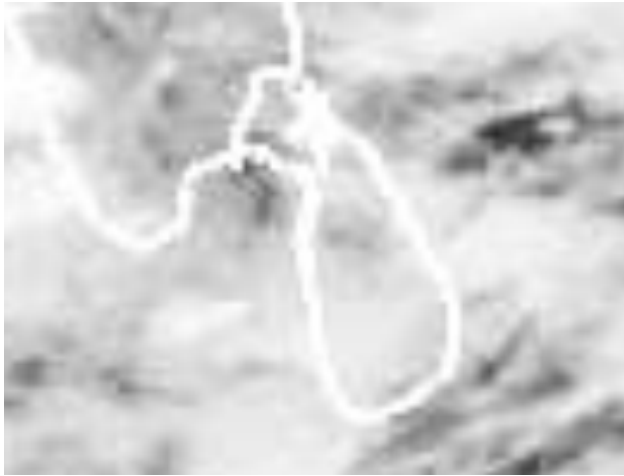
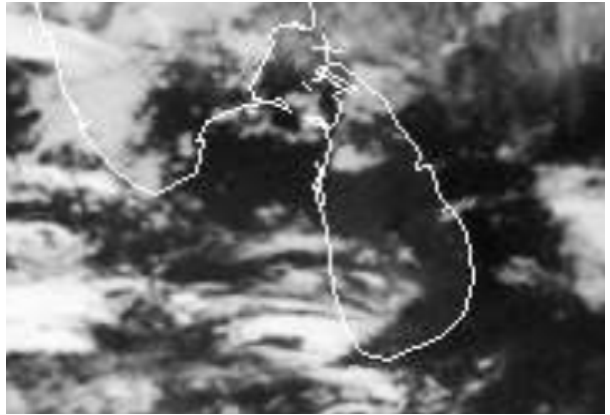
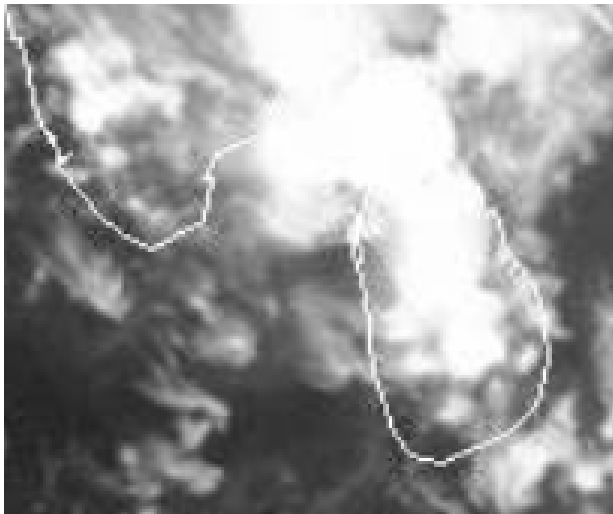
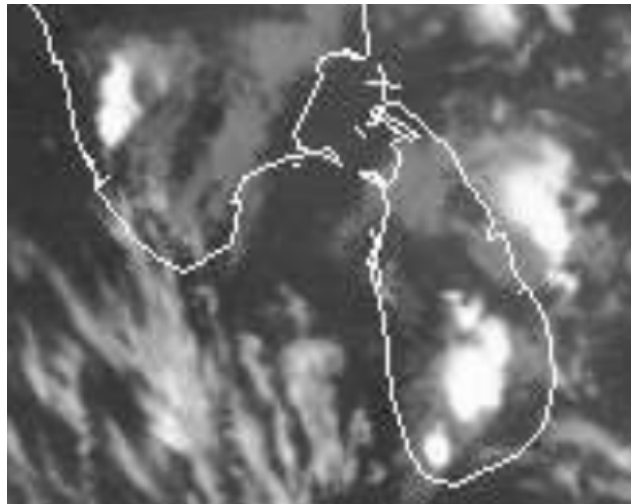
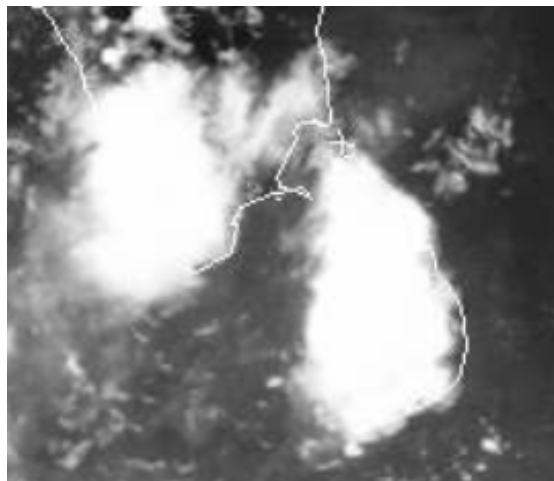
Visual thunder observation at each site and METEOSAT cloud imaginaries (Fig. 13-17) are used to verify whether lightning occurs in each site at particular time. It is clearly indicated that lightning has taken place in all five sites in fault reported dates and times.
