Coexistence of Automatic Weather Station (AWS) System in harsh environmental conditions at National Meteorological Centre (NMC) Colombo, Sri Lanka.

Nuwan Kumarasinghe

Department of Meteorology, Bauddhaloka Mawatha, Colombo 07, Sri Lanka.

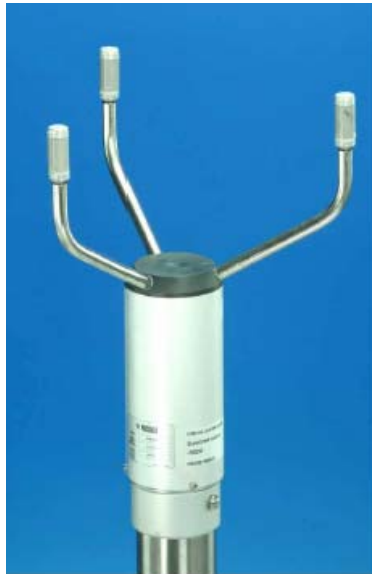
Fig. 2 *Vaisala WS 425*
Sensor

The transit time is measured in both directions for a pair of transducer heads. Using two measurements for each of the three ultrasonic paths at angle 60° to each other, WS 425 computes the wind speed and direction. This sensor uses very sophisticated electronic components which are susceptible for lightning surge currents.
